**FRACTURE PERFORMANCE
OF NGV CYLINDER DESIGNS**

Transportation Development Centre
Safety and Security
Transport Canada

Powertech Labs Inc.

March 1998

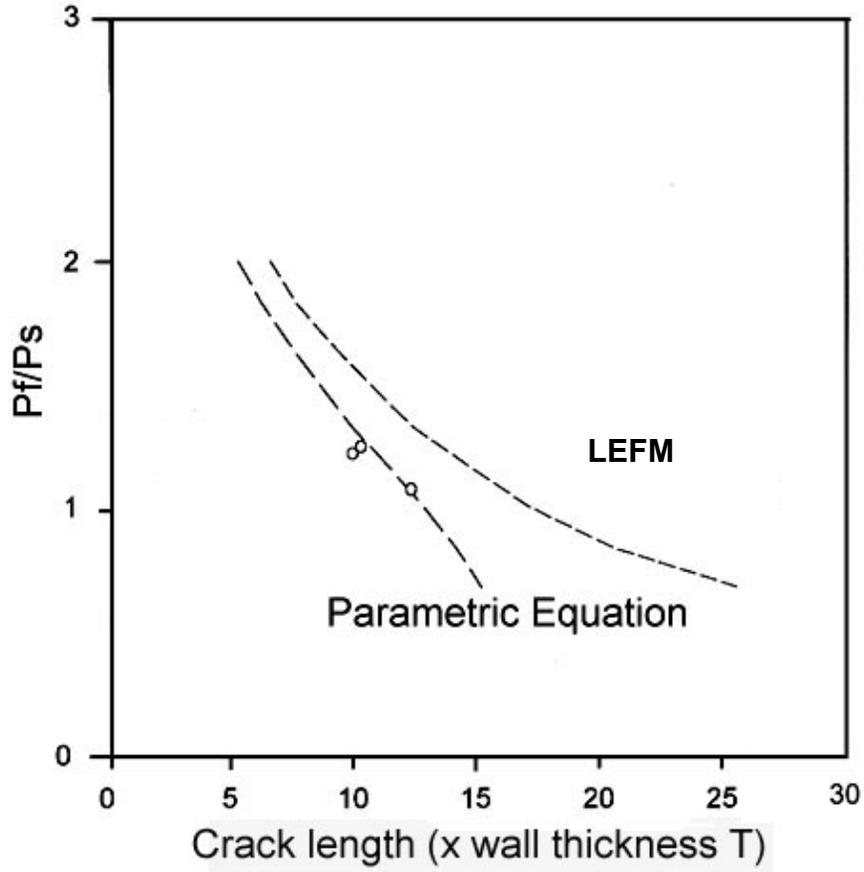
gsb138a

Figure 1-4 Comparison between parametric equations, the LEFM approach and the experimental data for the Data Set A. (Faber steel cylinder). Open circles indicate leak.

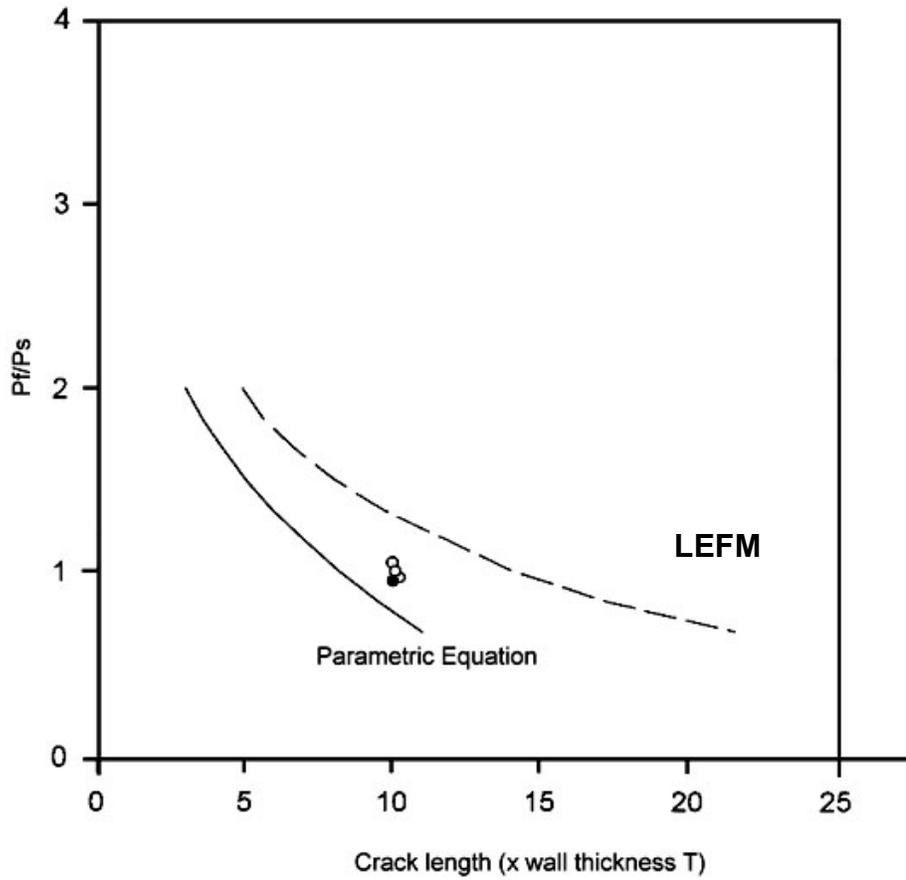
gib138b

Figure 1-5 Comparison between parametric equations, LEFM approach and the experimental data for the Data Set B. (Taylor-Wharton steel cylinder). Open circles indicate leak. Closed circles indicate fracture.

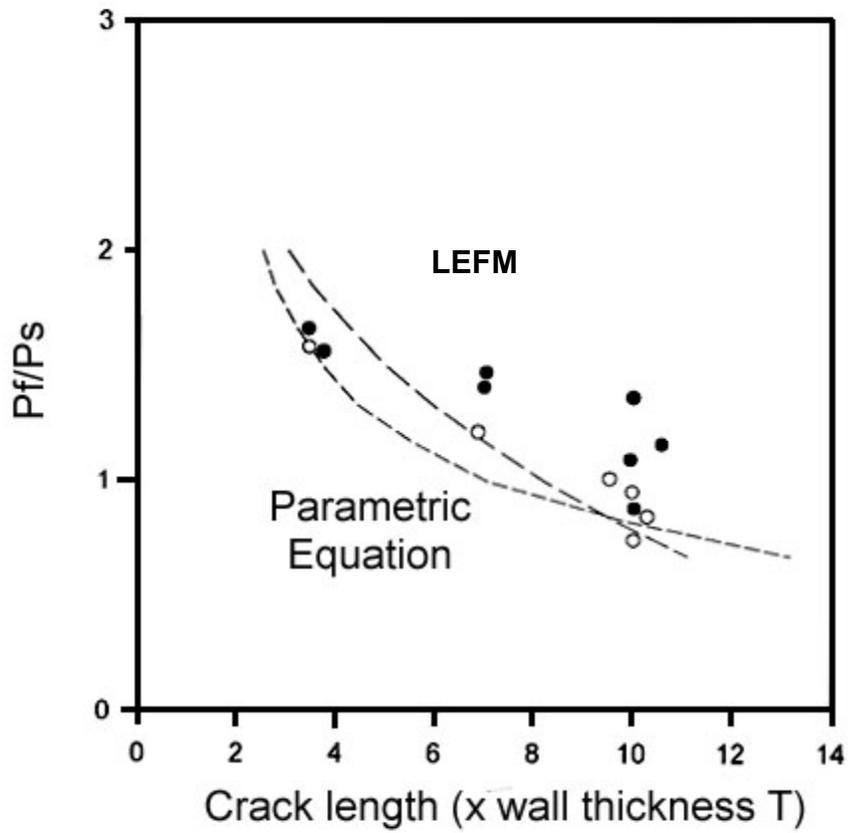
gsb138c

Figure 1-6 Comparison between parametric equations, LEFM approach and the experimental data for the Data Set C. (DOT 3AA WG14 steel cylinder). Open circles indicate leak. Closed circles indicate fracture.

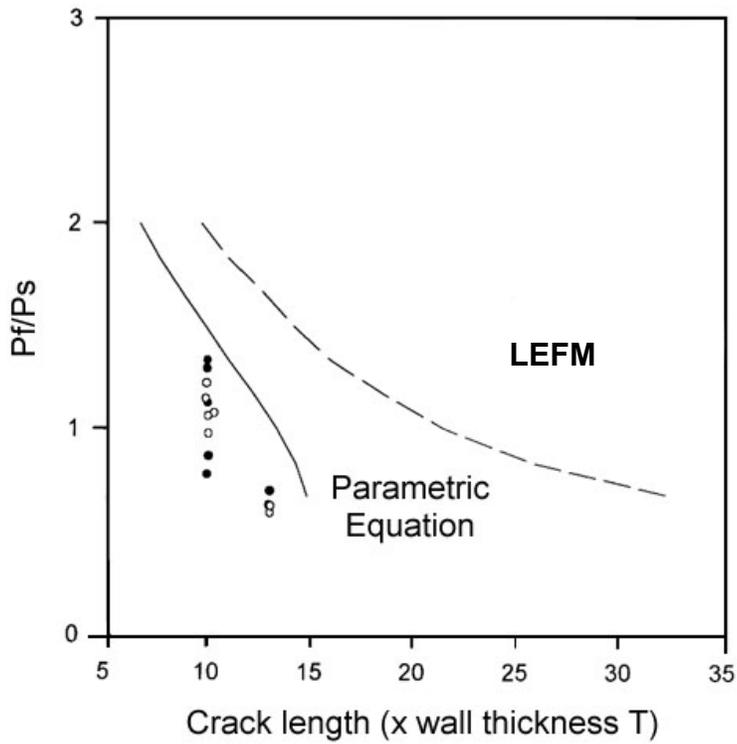
gsb138d

Figure 1-7 Comparison between parametric equations, LEFM approach and the experimental data for the Data Set F. (DOT 3T WG14 steel cylinder). Open circles indicate leak. Closed circles indicate fracture.

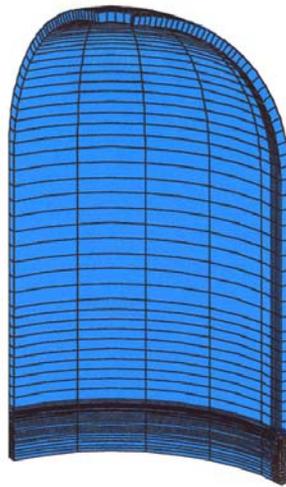
83m-1

Figure C-1: Finite element model of the Faber steel cylinder with a 10T long axial internal flaw

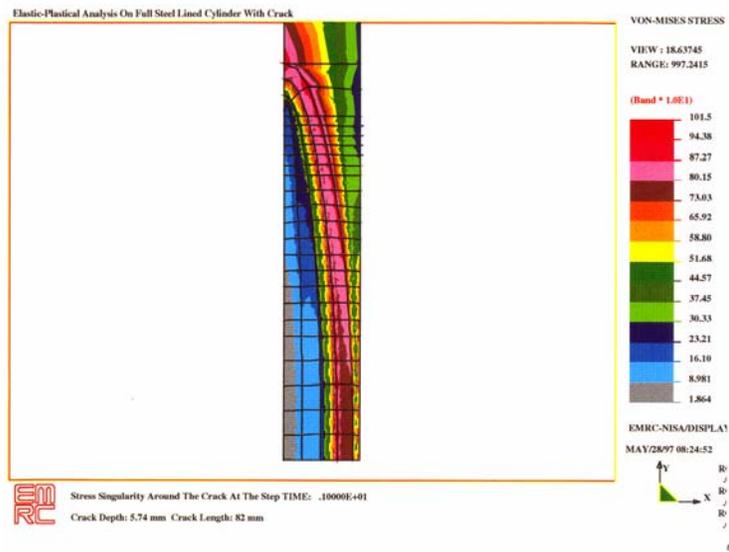
Figure C-2: Von-Mises stress contour of the Faber steel cylinder at an internal pressure of 3,750 psi [25.8 MPa] ahead of the crack front obtained from elasto-plastic analysis.

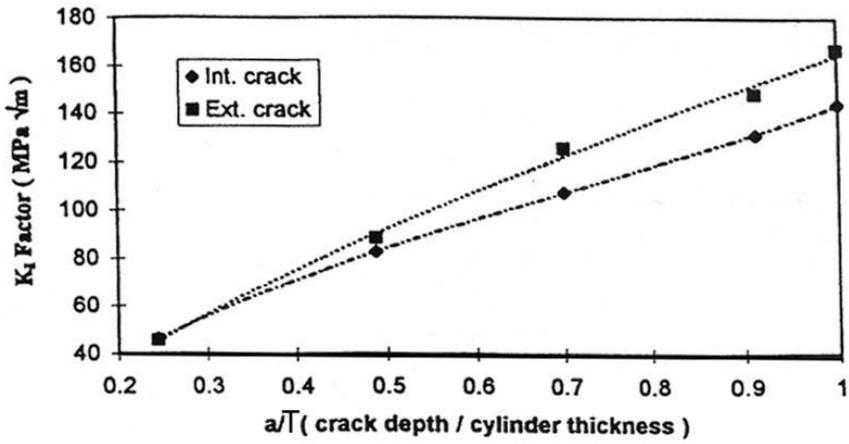
gsb88r

Figure C-3: Effect of crack depth of semi-elliptical internal & external surface crack on crack driving force in a Faber all-steel cylinder under a pressure of 3,750 psi (25.8 MPa)

An analysis of the stresses associated with a crack in the wall of a cylinder (see Appendix C) determined that externally machined flaws actually provided a more severe test of LBB performance. This occurs because the crack driving force on the internal surface of a cylinder is higher than that on the external surface; consequently, the remaining ligament of a flaw machined into the external surface of a cylinder will be under a higher force at the moment of failure than the remaining ligament of a fatigue crack growing outward from the internal surface of a cylinder. As a result, all burst tests were conducted using either water or compressed nitrogen on cylinders containing flaws machined into the external surfaces. The resulting cylinder fractures were then compared to determine if any relationship existed.
